Incorrect Coil Storage

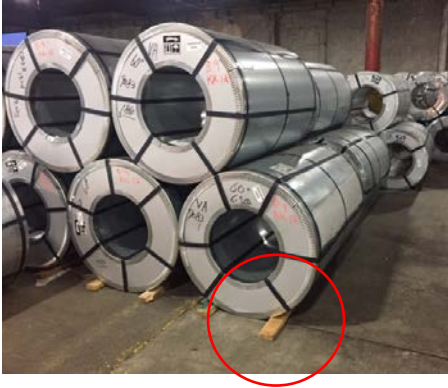
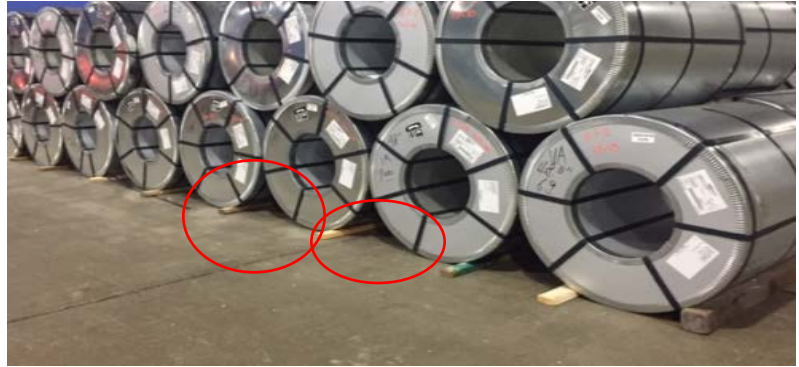
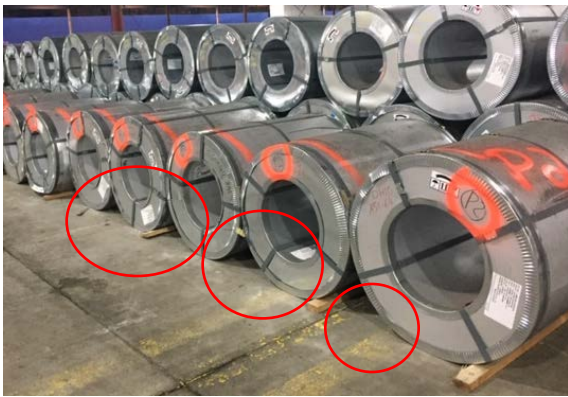
Coils in WHSE 1 have been binned with incorrect dunnage placement. 4x4's are missing from the ends of some piles and some coils do not have 2x4's on both sides. With incorrect dunnage placement, there is a strong potential for the entire stow to roll when the pile is being broken down.

- All coils on the base row must be chocked with minimum 2x4 dunnage.
- Dunnage must be placed firmly and centrally against both sides of the coil.
- The ends of every row are to be secured with minimum 4x4 dunnage.
- For the safety of everyone, this safe work procedure must be adhered to.
