SAFETY ALERT

ARM CRUSH INJURY

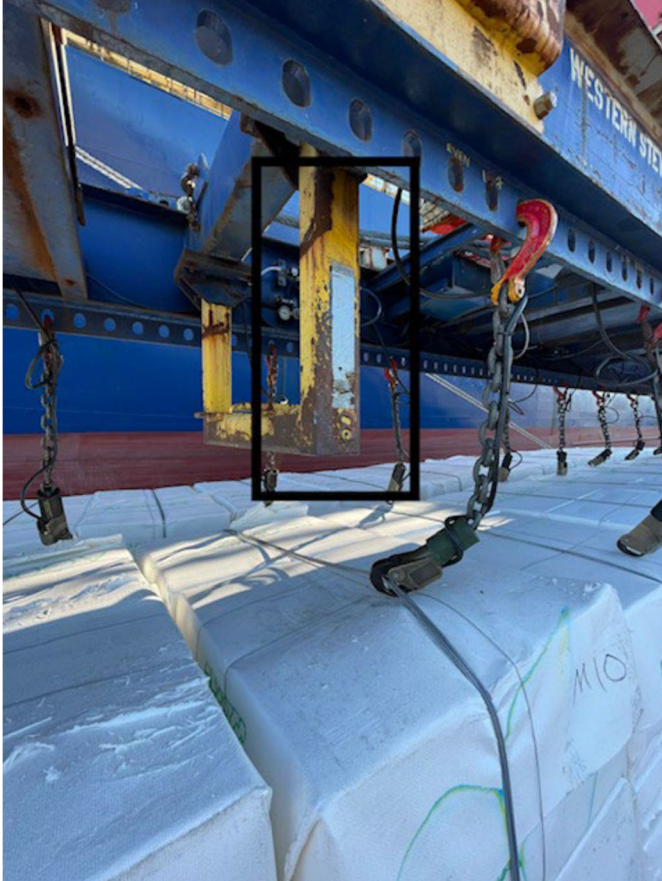
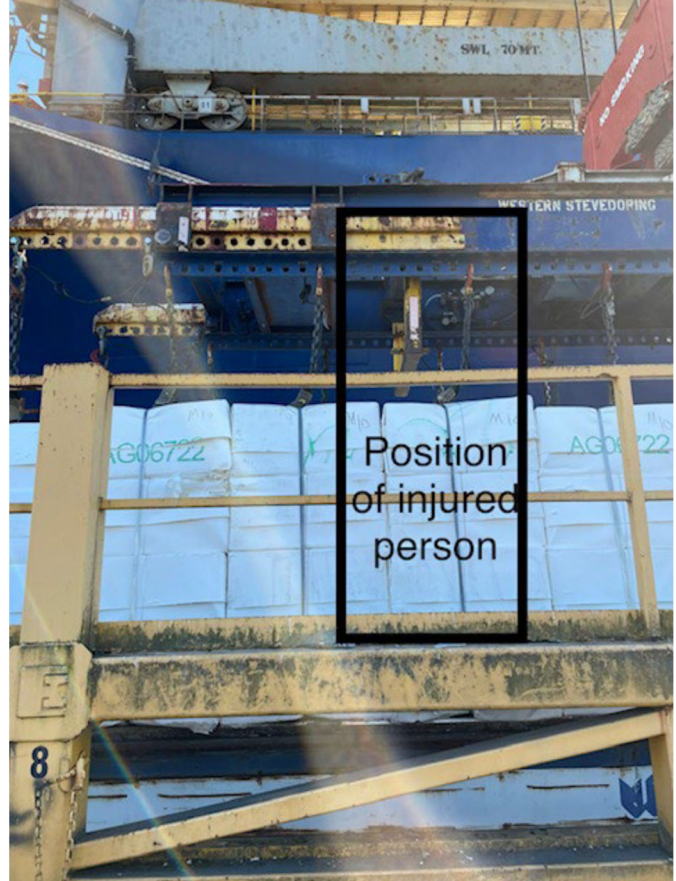
Workers arm and wrist was crushed when arm was placed underneath frame

- Workers should be mindful of other operations on vessel which could cause listing of vessel
- Longer chains on each hook can reduce the risk of recurrence
- Reconfiguring the design of the legs on single wide frames
