SAFETY ALERT

CARGO HOOK— FALLEN LIFTING GEAR

OTAGO—NEW ZEALAND SSA

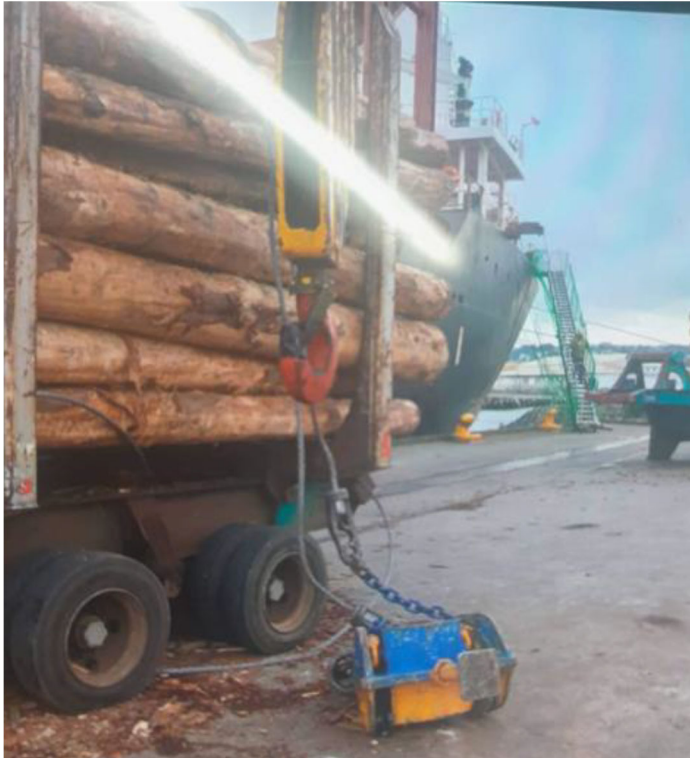
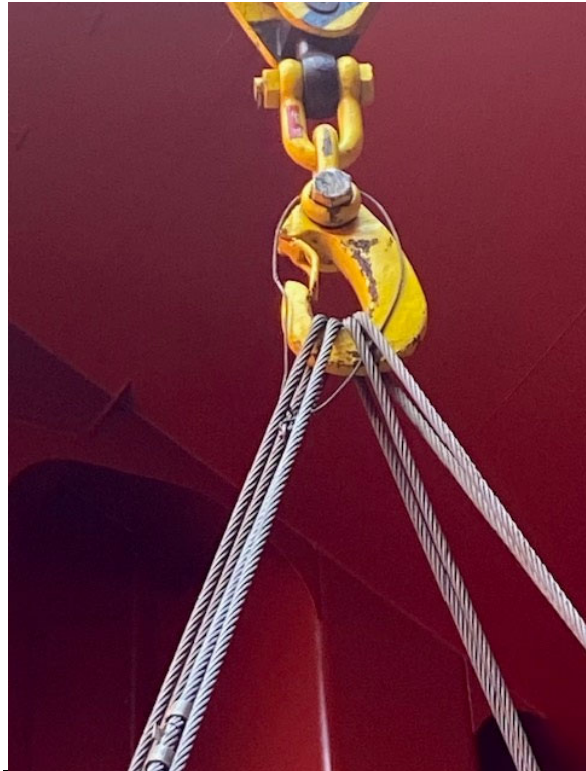
During the loading of a log vessel the lifting tackle (wires, chains, and attachments) came off the hook of the ships crane and fell a height of 20 feet to the ground. The lifting tackle landed approximately 6 feet from the wharf hand (Longshoreman) on the ground

- All keepers were inspected with security wire placed between bridals and cargo hook shackle
- Ensure lifting tackle arrangements are designed to connect with each other and in SWL e.g., lifting wire, chains and shackles are all within same capacity.
- Ensure safety latches on hooks are in working order and secure to prevent displacement
