# SAFETY ALERT

## CARGO HOOK—SECURITY WIRE

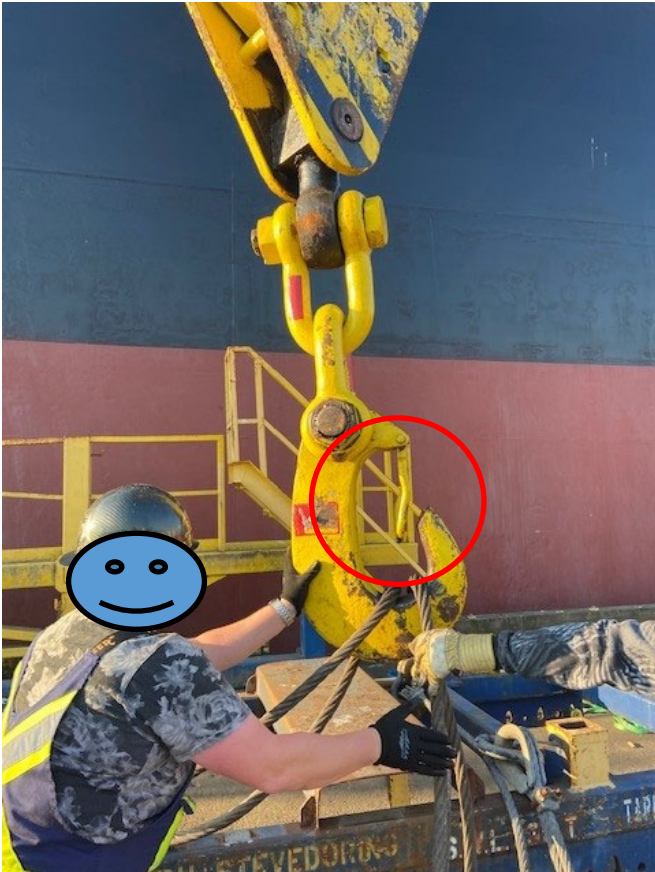
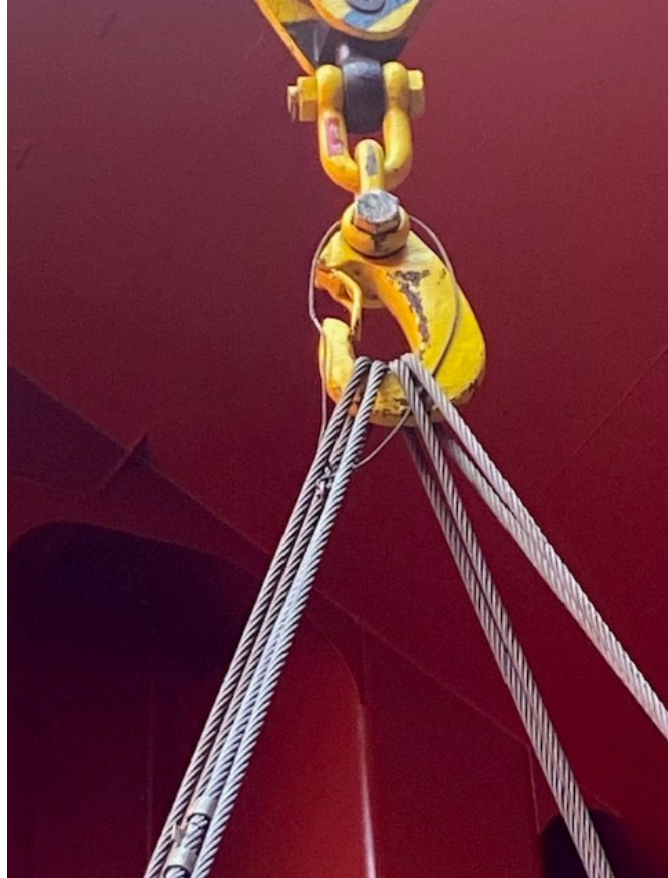
The spring loaded keeper which prevents wires from coming off the cargo hook was not working correctly, and the angle of the hook allowed the keeper to open—causing wire to come out.

- All keepers were inspected with security wire placed between bridals and cargo hook shackle

- Review topside training to ensure they are checking keepers during initial inspection
- Ensure all supervisors are aware that there is a security wire between wire grommet (bridal) and the shackle when clasp is not working as intended
